ACEGrid® a Road Slope Repair Project in Taiwan

Location: Taitung County, Taiwan

Application: MSEW and Reinforced slope in Road Repair

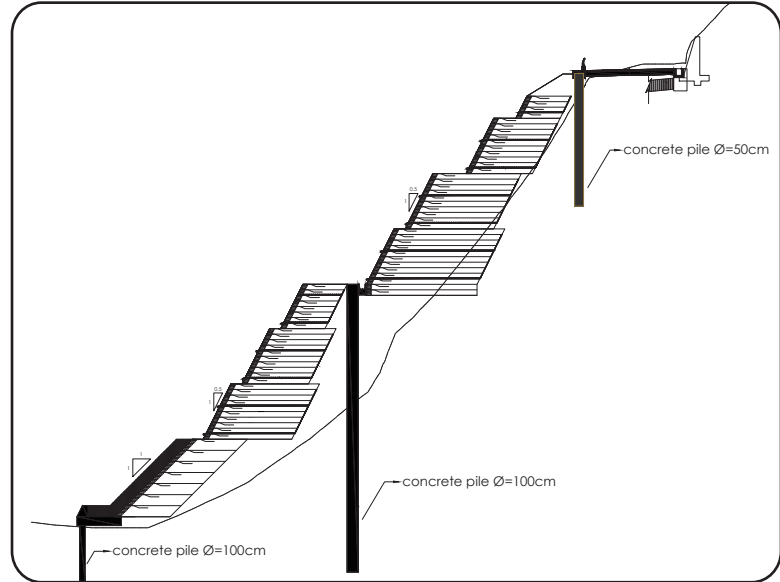
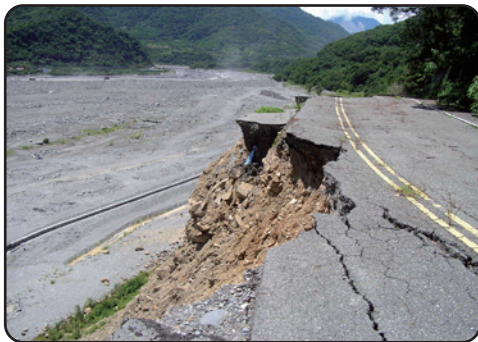
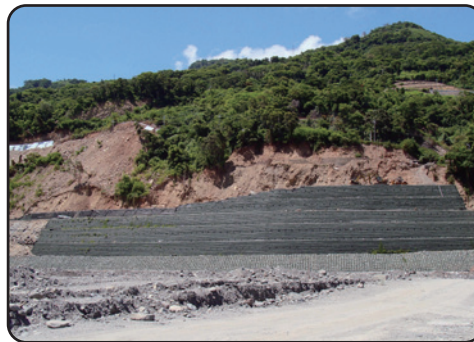
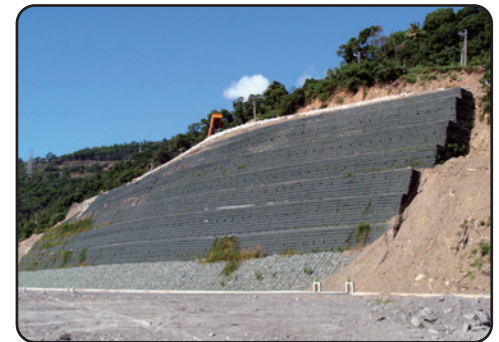
In 2009, Typhoon, Morakot, attacked South Taiwan seriously. The abundance amount of rain caused flood which removed toe of slope and brought about wide collapse of slope. The collapse area was 50m in height and 200m in width. The Road, East No. 64 was destroyed and disconnected for several months.

The structure included concrete base, 7m reinforced slope, 35m reinforced retaining wall, and 3 concrete piles located below base and behind reinforced retaining wall. The reinforced slope was protected by gabion face against flood scour. Above that a total height of 35m wrapped reinforced retaining wall was divided into 7 stages. Vegetation mat was hanging in front of retaining wall face for plant growing. Concrete piles were installed to prevent failure of global and/or compound stability. Drainage system inside retaining wall drained out water from retained soil and reinforced zone.

The construction was finished on Nov. 2011 and restored the traffic connection. Considering construction efficiency and cost, most of fill used in-situ soil. Construction using in-situ soil was helpful for original plants growing. Thanks for abundant rain and nice weather, the wall became green and environment friendly.
