## *Protection of Pier Foundation of Zhongsha Bridge at Zhuoshui River, Taiwan*

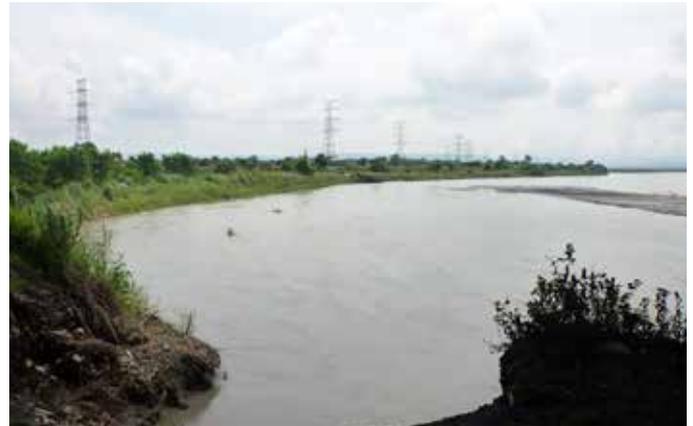
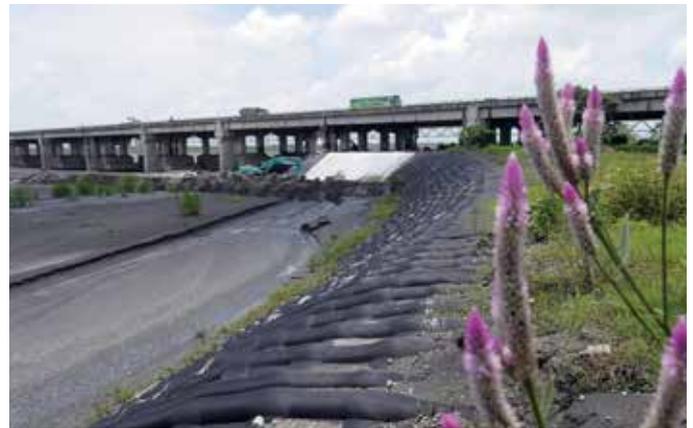
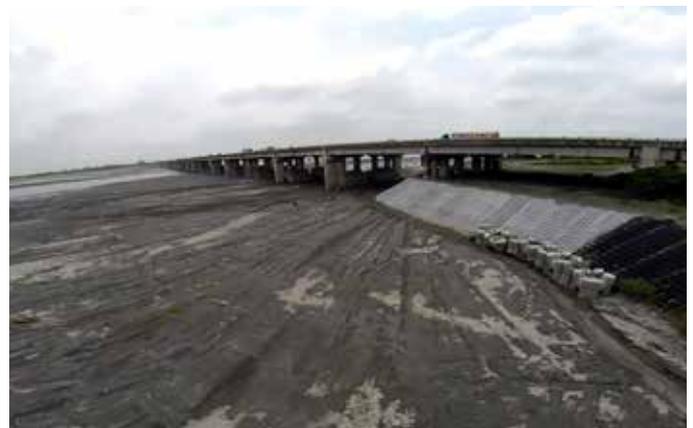
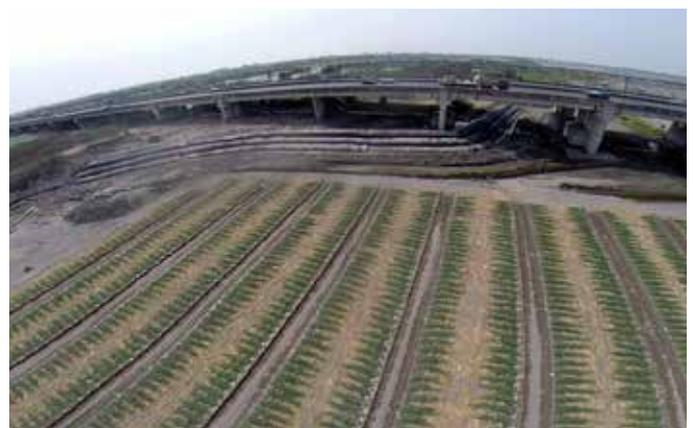
In this project geotextile tubes ACETube® and geotextile mattresses ACEFormer™ were used to solve the abovementioned problem. The protection was designed to be 5.6m high with four layers of ACETube®. After each layer of ACETube® was filled with in-situ sand, gravel in-situ soil was then placed and leveled on the top to make an even surface for the installation of the following layer. Such procedure was repeated until the four layers were finished.

At the end of construction, the four-layer structure was covered with ACEFormer™ filled with concrete mortar which not merely increased the impact resistance of the structure and kept ACETube® from external damages caused by driftwood or debris coming down the river but, in the meantime, also enhanced the stability of pier foundations and embankments. Furthermore, the mattresses used here were the ones with permeable filter points which allowed the excess water in the structure to discharge into the river and, thus, maintain the structure more stable. The uneven surface of ACEFormer™ also helped reduce flow velocity and slow down the erosion process.
