ACEMat™ for Slope Erosion Control Project

Location : Chiayi, Taiwan

Application : Erosion Control and Revegetation

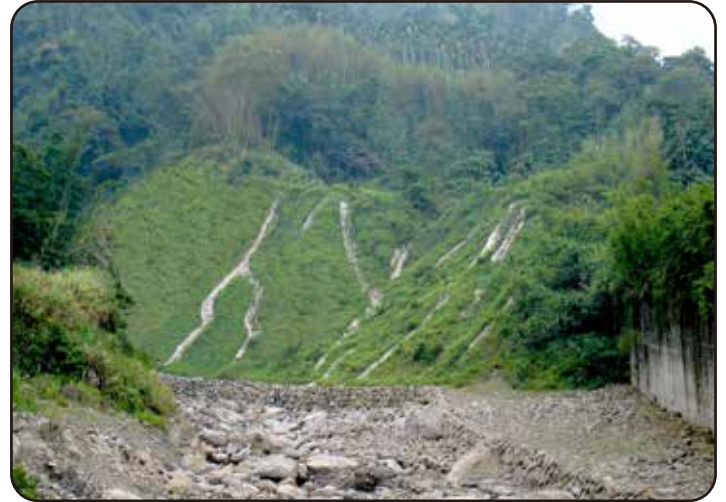
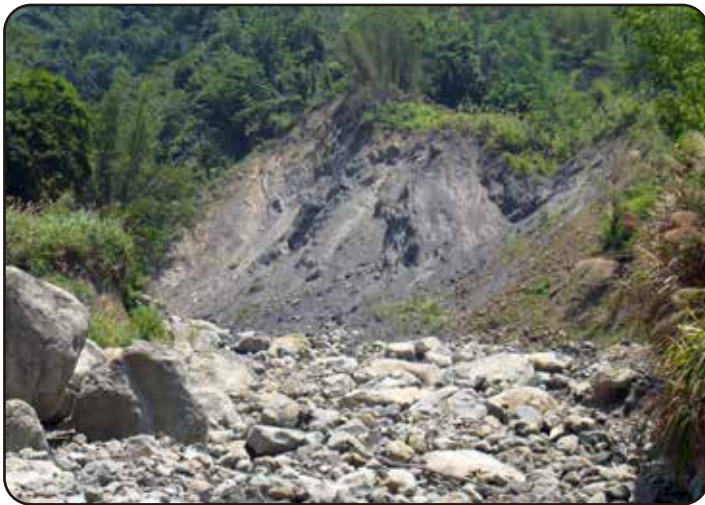
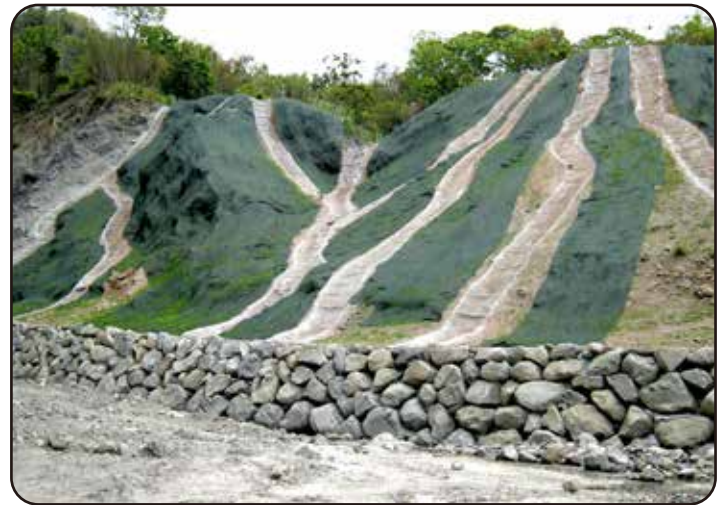
This case was located in Zhuqi Township, Chiayi County. As a result of the typhoon Morakot attacked, heavy rain and torrential streams destroyed the embankments. Therefore, the embankments were damaged and the slopes were collapsed by heavy rain. So we had to make an urgent repair to stabilize slopes.

We restored vegetation recovery by using the method of stone-paved embankments and hanging-net vegetation. And we also set vertical direction ditches and horizontal direction ditches in order to drain quickly. This engineering scheme could approach not only energy saving and carbon reduction but also environment greening by using the method of stone-paved embankment and hanging-net vegetation. Using greening material of hanging-net vegetation and combined with in-situ natural stones to construct a stone-paved embankment, thus the construction could achieve the goal of ecological engineering. The result of hanging-net for revegetation and slope protection engineering provided an excellent environment where animals and plants could live here, and also decreased the frequency of material transport during construction.
