Urgent Slope Repair in National Chengchi University

Location: Taipei City, Taiwan

Application: Slope Protection

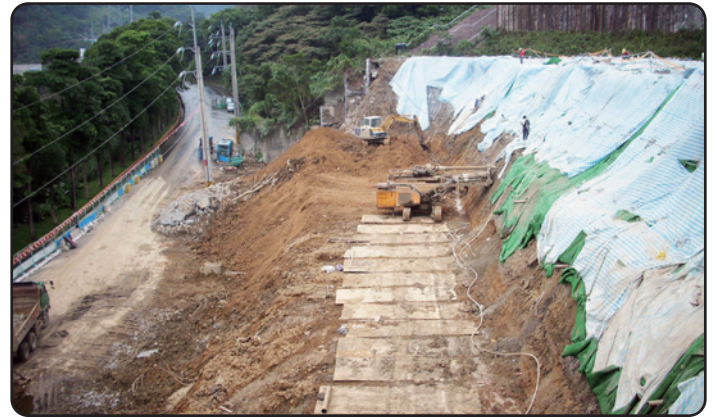
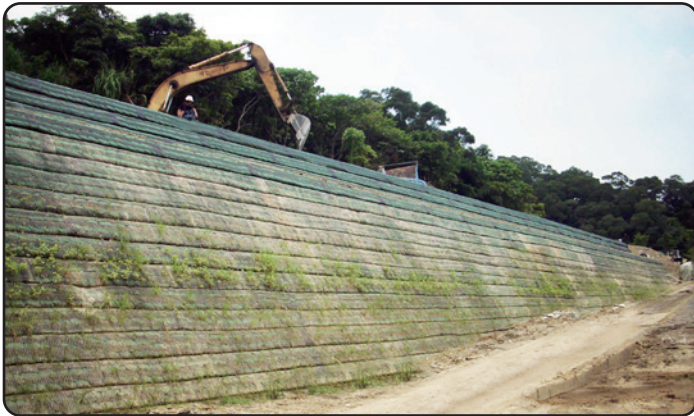
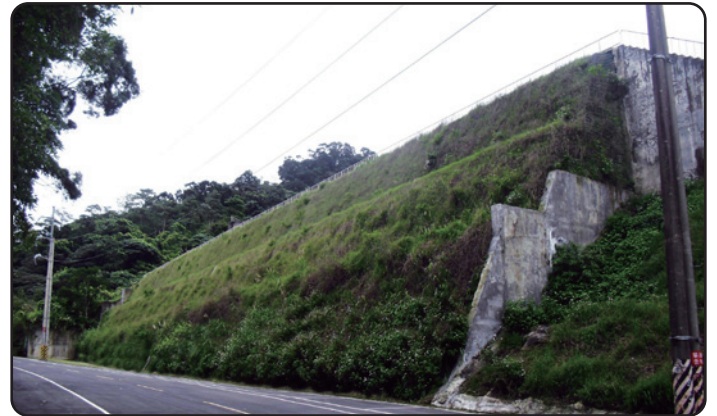
On September 2008, a series of strong typhoons attacked Taiwan continuously. Due to the heavy rain day after day, the reinforced concrete wall below the athletic field, in National Chengchi University, was collapsed. In order to recover traffic and sport field immediately, to repair the damaged slope in a short time is needed.

In light of carbon emission reduction concept, three stairs of wrap-around reinforced structures are built on the existing reinforced concrete foundation. The maximum height of reinforced structure is around 15m.

To prevent the slope damage from runoff or seepage, horizontal drainage pipes are arranged in the existing slope and connected with the drainage system of reinforced structure to discharge groundwater behind the reinforced wall.

Here low-carbon construction material – ACEGrid[®] is applied as strength provider. Until now, the reinforced structure is quite stable and brings the lush green even if typhoons keep coming.
