Sand Barriers Restoration Project Utilized ACEBag™

Location : Tainan, Taiwan

Application : Coastline Protection

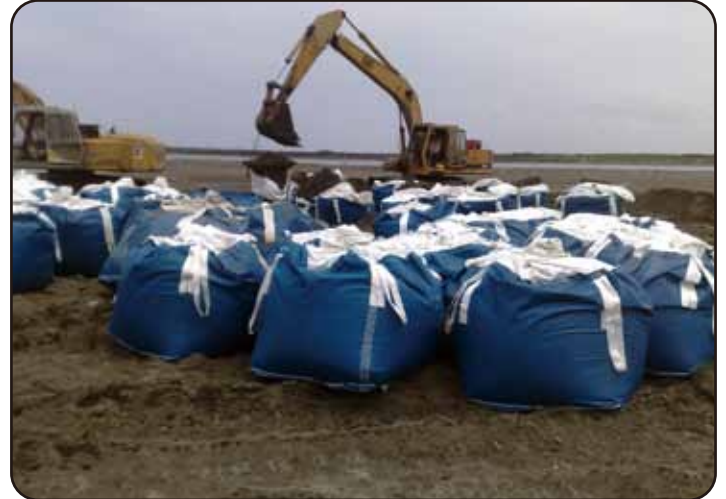
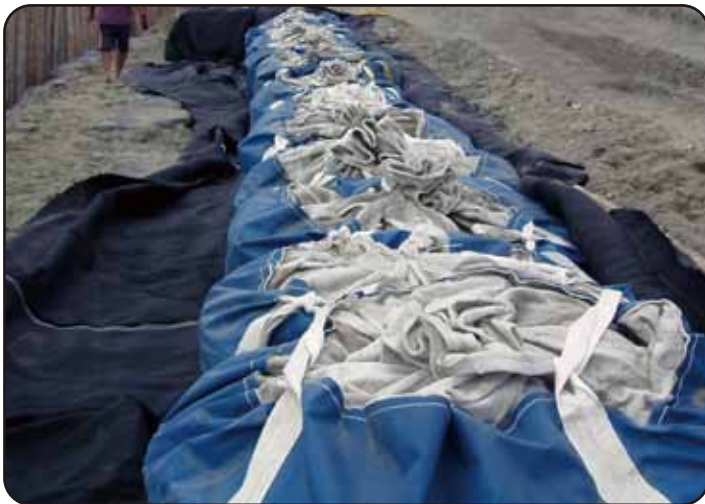
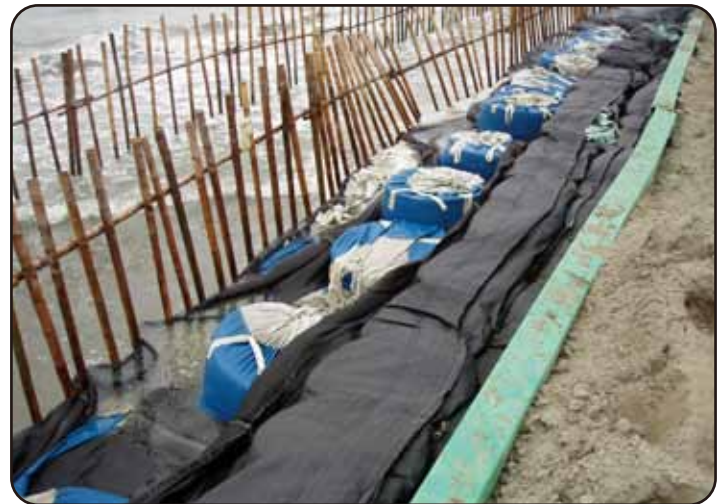
In 2008, the engineering company drove the plastic sheet piles into the beach where the sand bar was attacked by waves to resist the scouring, stacked ACEBag™ in the foreshore to firm the beach sand, and covered ACETex® for extending the service life of whole restoration system. The protected system was completed, dredged sand to nourish the backshore. The sand barriers restore its function to surround and safeguard the valuable lagoon.
