Geosynthetics

CASE STUDY COLLECTION

Roadway and Railway Construction

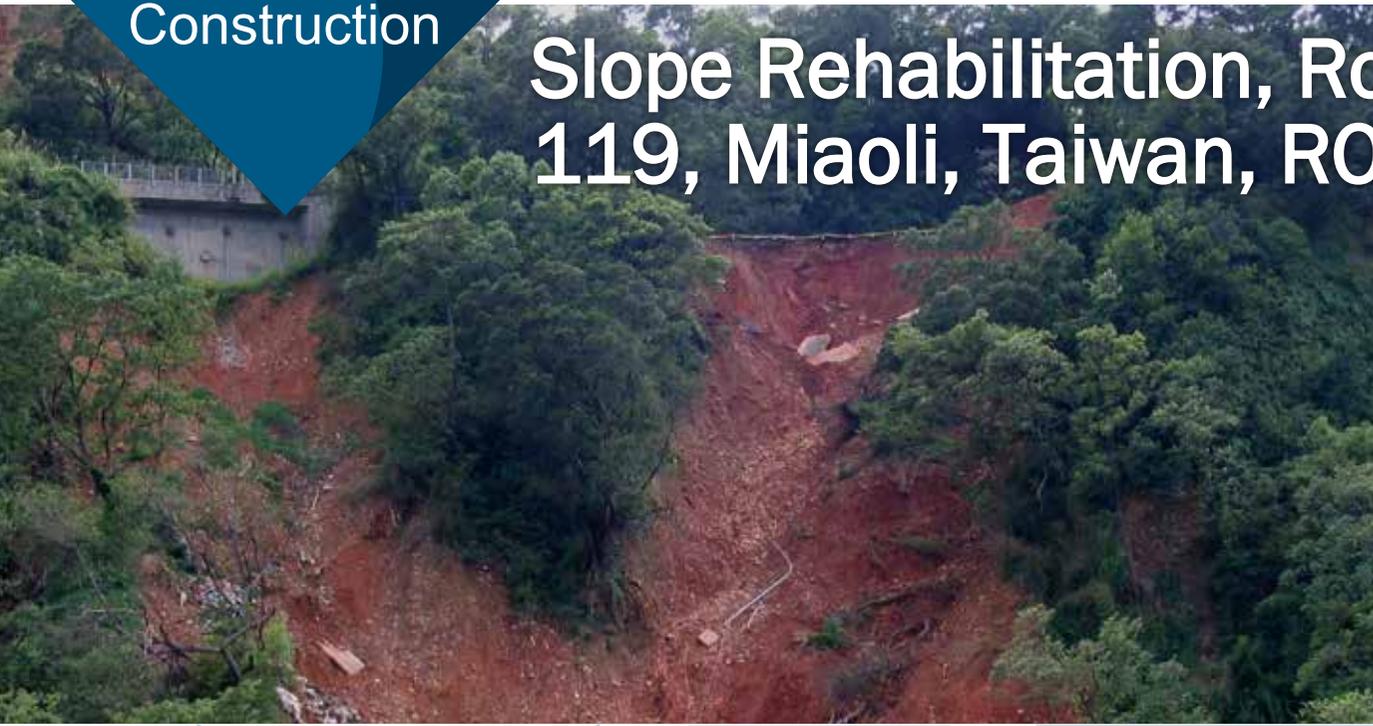
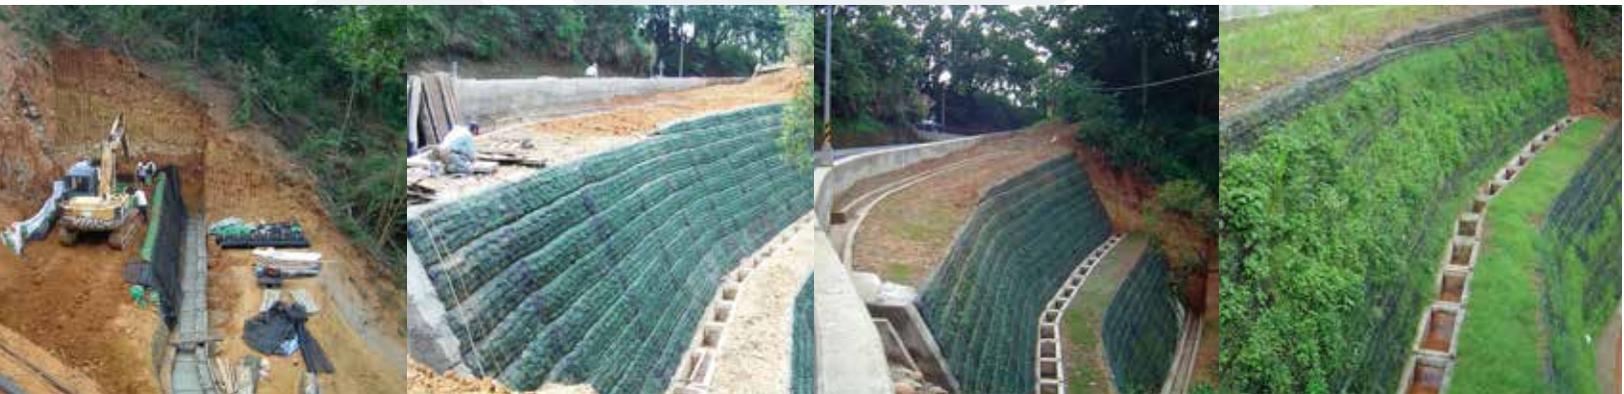
Since the in-situ gravelly clayey sand could be utilized to cut down construction cost, reinforced earth slope (RES) with ACEGrid[®] was adopted for this project. It was 10m in height and 34m in length, supporting by a reinforced concrete mat foundation with steel H piles at the toe. The RES was constructed in two tiers with geogrid wrap-around facing setback with an inclined ratio of 1:2(H:V). Stacked soil-filled and hydro-seeded ACEBag[™] was used for slope face protection and visual integration with the surrounding environment. For damaged slope below RES, high strength geomat, extending 50m downward was installed and vegetated. It was designed for erosion protection and for scenic improvement at the site. Lastly, intercept trenches and New Jersey guard rails were installed for surface run off drainage and traffic safety.

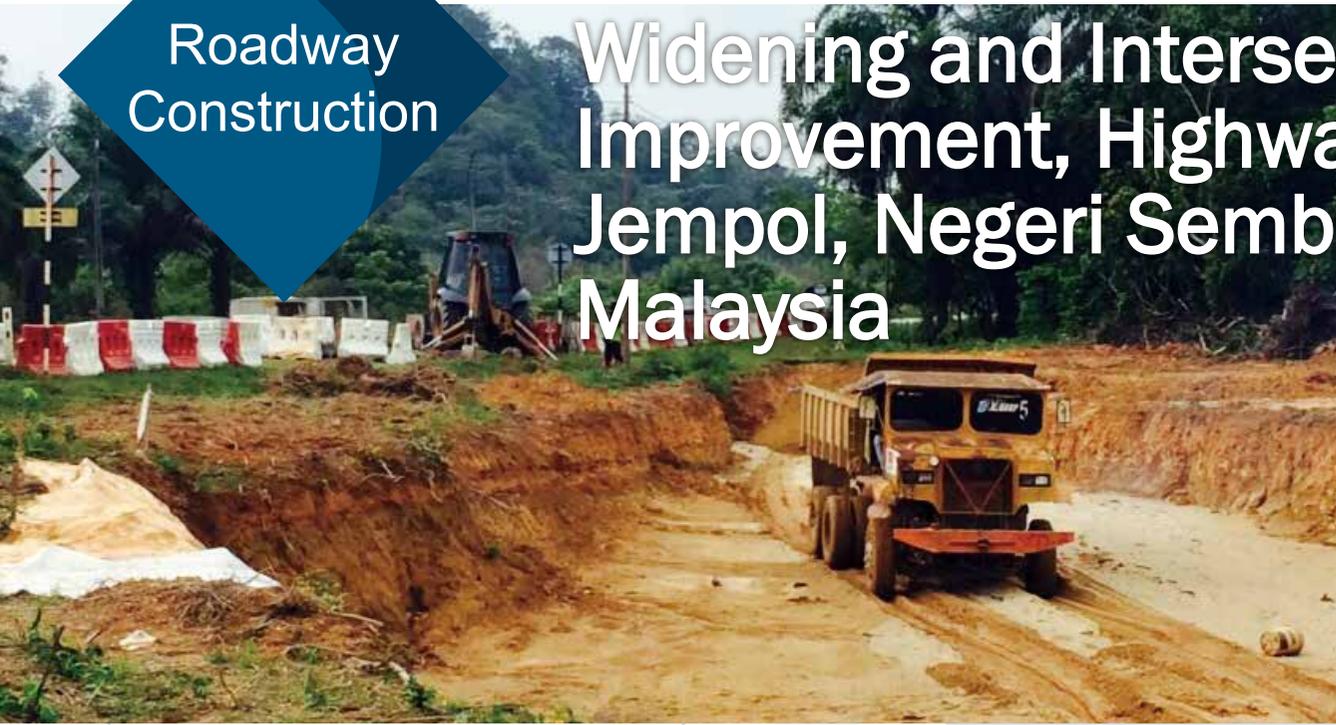
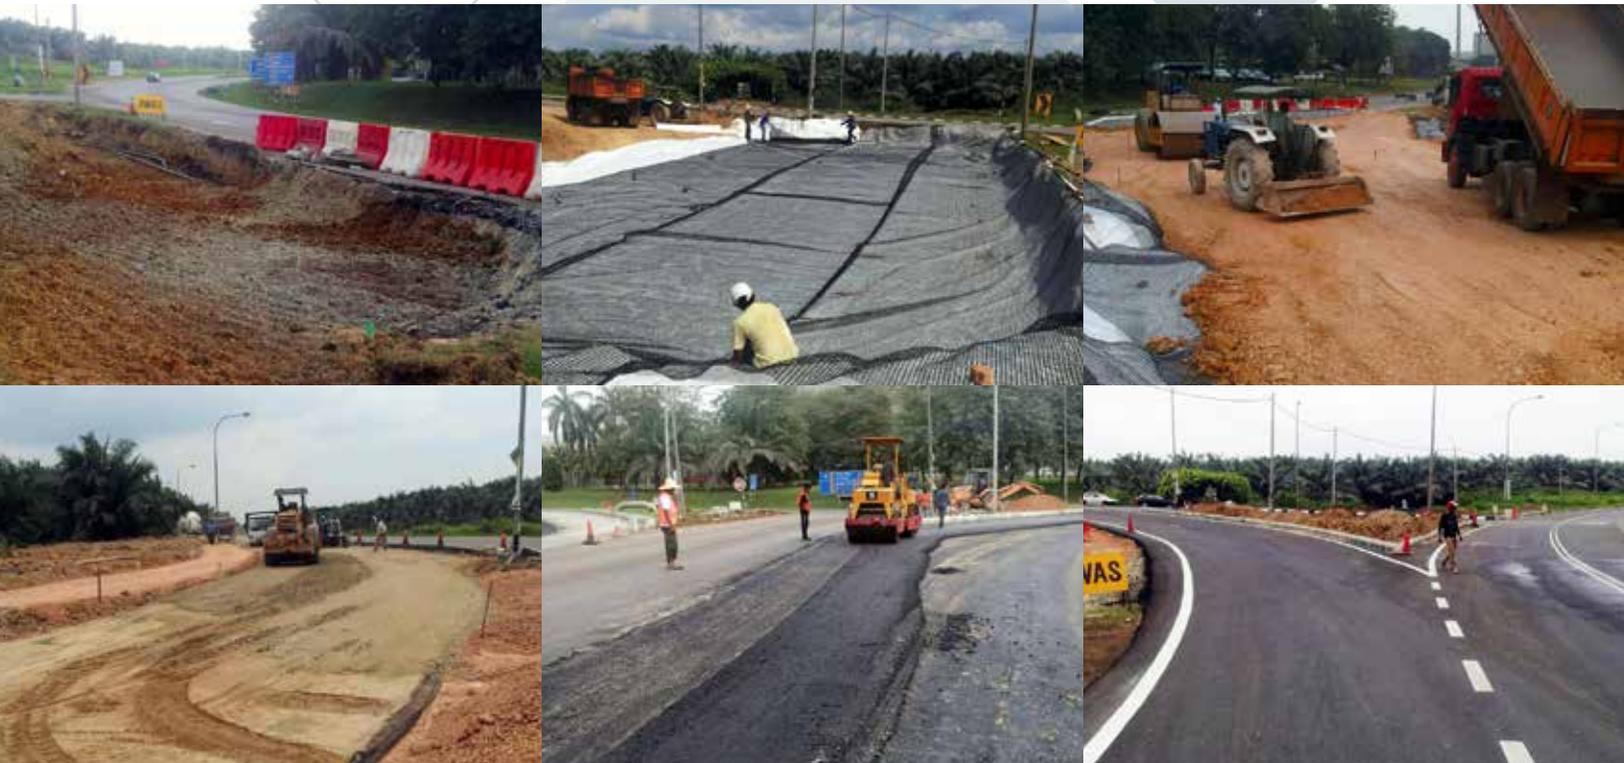
To solve this problem and help construction operate more smoothly, the contractor first raised the grade to one meter below the design elevation by filling satisfied site material. Then, ACE ground stabilization system was placed to reinforce the weak subgrade. It consisted of a layer of ACETex[®] and a layer of ACEGrid[®]. ACETex[®] was designed for filtration and drainage, and ACEGrid[®], a bi-axial high resistance product, was installed for bearing capacity improvement. A 45cm thick compacted fill was then placed and a second layer of ACEGrid[®] was installed. Geogrids fully interlocked with soil particles created an enhanced composite material with higher performance characteristics. Crushed base course and asphalt concrete surface course was each then placed as those procedures for traditional pavement construction.

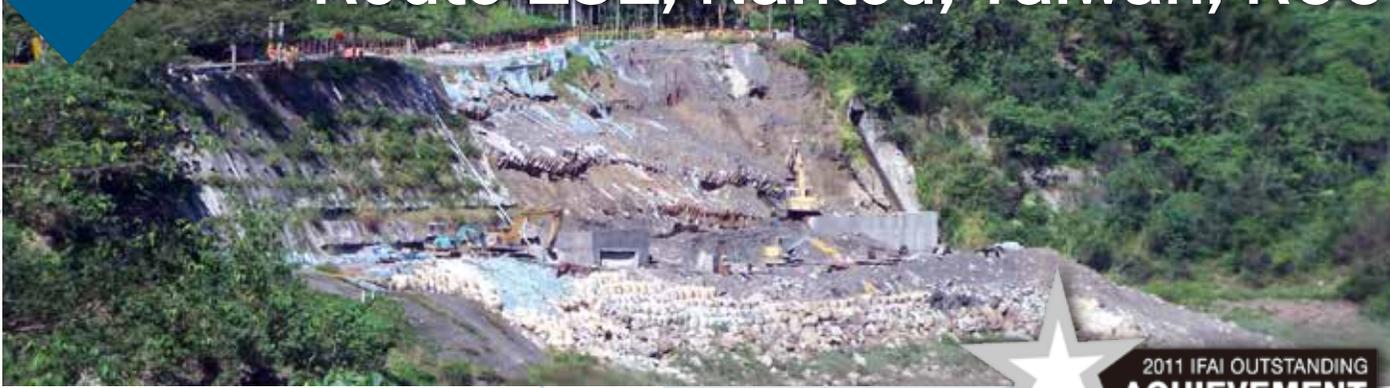
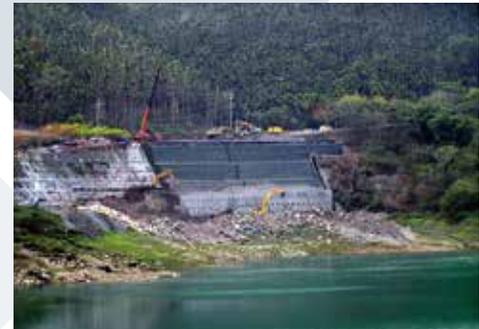
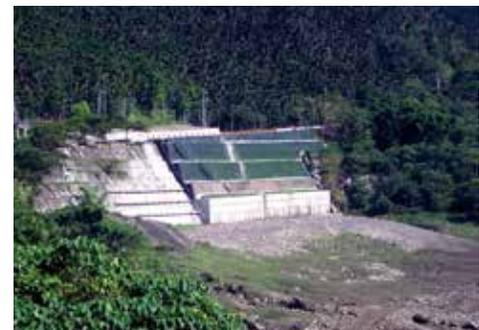
The site is located in the water supply reserve area of Ming-Tan Reservoir. The toe of the slope was vulnerable to scouring due to water level fluctuation in the reservoir. After careful stability analysis, a composite protection system was adopted. To meet all the requirements of the project, the rehabilitation consisted of two stages. In stage I, a pile-supported reinforced concrete (RC) waterfront protection wall was built for the lower slope below the highest water level. Drilled concrete piles (1.5m in diameter, 20m to 30m long, 2.5m in space) were used to support the protection wall (8.5m in height). Ground anchors also were installed to give additional tie-back resistance. The durable RC structure was designed to prevent any possible instability from scouring. In stage II, a wrap-around reinforced earth structure (RES) containing ACEGrid[®], ACEBag[™], and drainage materials were chosen to restore the slope above the protection wall. The RES was constructed in 4 sequential tiers up to a final height of 17m using geogrids 8 to 10m long. Each tier was setback with an averaged inclined ratio of 0.3:1 (H:V). Stacked soil-filled ACEBag[™] was used for slope face protection. It also functioned as the medium of planting as vegetated slope was not only good for an aesthetic appearance but also for an eco-friendly environment. Interior and surface drainage systems were also installed properly for the RES to effectively drain the seepage and run-off.

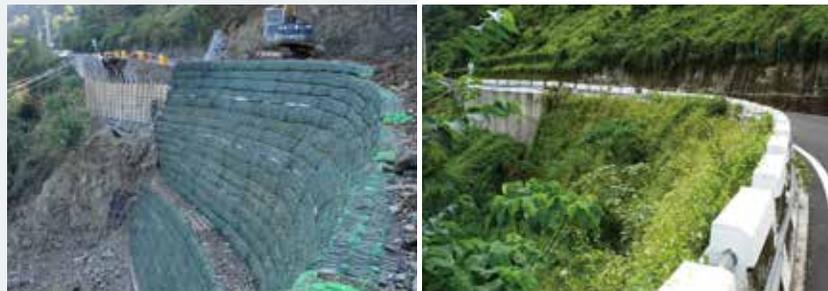
Considering cost, efficiency, sustainability, and site conditions, the designer introduced a composite protection system for the rehabilitation. Firstly, a reinforced concrete mat foundation with drilled root piles were installed as base support. Then, the designer contracted representatives of ACE and adopted ACEGrid[®] as the reinforcing material to build a 3-tier reinforced earth slope (RES) to support the highway. Additional soil nails, tied up securely with geogrid, were installed to dowel the deep-seated failure plane to ensure stability. RES was constructed with geogrid wrap-around facing set back with an averaged inclined ratio of 1:2 (H:V). It was built in layers using the collapsed residues on site. Fill materials were placed and geogrid installed at a vertical spacing of 50cm and they were piled up until reaching the final height of 16~18m. Soil-filled and hydro-seeded ACEBag[™] was stacked for slope face protection. They also functioned as the medium of planting as a vegetated slope not only provides an aesthetic appearance, but is also an eco-friendly environment. Interior intercept trenches and horizontal drains were also arranged to prompt the dissipation of groundwater. Finally, longitudinal and horizontal trench systems were installed to facilitate the drainage of surface run-off.

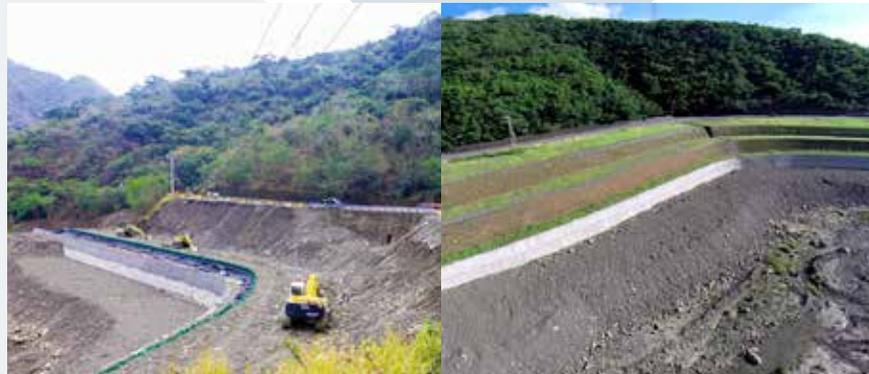
To meet all the requirements of the project, the rehabilitation consisted of two parts. In part I, a 150m long, pile-supported reinforced concrete (RC) waterfront protection wall was built for the lower slope below the highest water level. The piles were designed with a diameter of 1.2m and a minimum length of 10m. A total of 155 piles, each spaced 2m, were installed in two rows with all-casing drilling technology and seated into the bedrock for at least 2m. The durable RC structure was used to prevent the instability from river scouring.

In part II, a wrap-around reinforced earth structure (RES) containing ACEGrid[®], ACEBag[™], and drainage materials were chosen to restore the upper slope. The RES was constructed in two stages using collapsed debris piled on-site. Each stage has a height of about 5m with an averaged inclined ratio of 1:2 (H:V) so that a sufficient width of the highway can be maintained. Considering the safety and the cost, stage I applied stronger ACEGrid[®] (Type A geogrid) as the reinforcing material for a total area of 1,326m² for the lower part of the RES. Another 995m² of ACEGrid[®] (Type B geogrid) with lesser strength was used for the upper part of the RES. Each layer of the fill material was installed with a vertical spacing of 50cm.

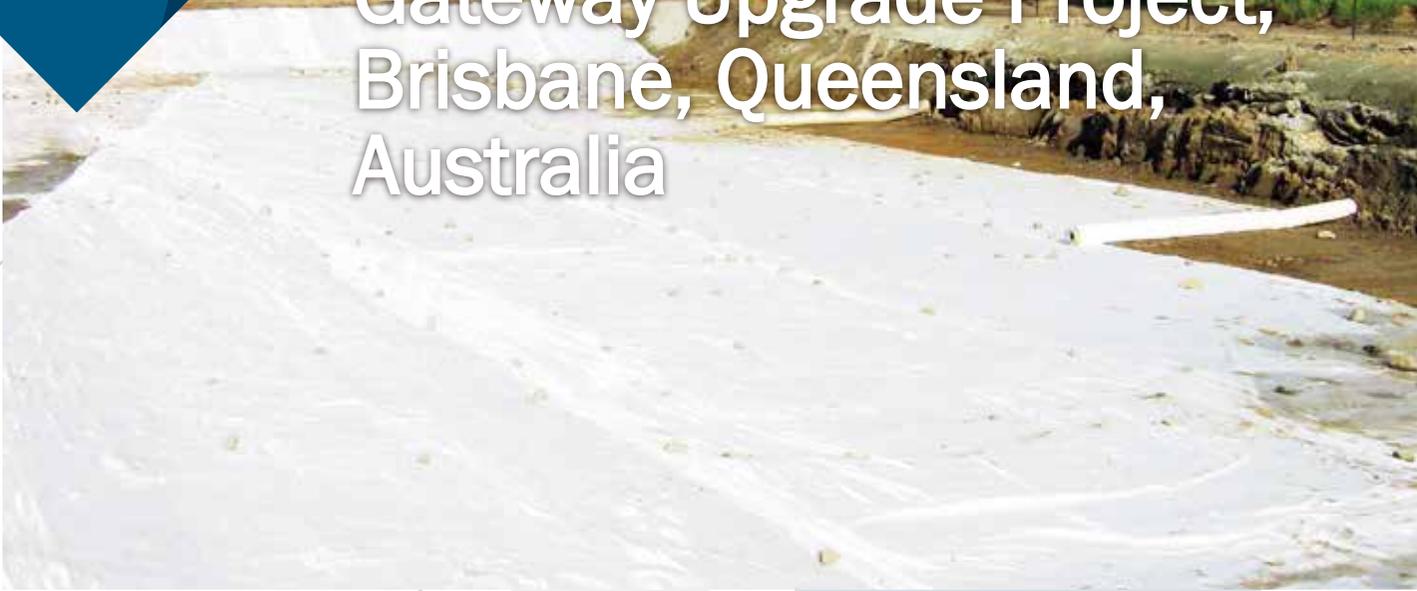
Managing authority of Queensland Motorways proposed to upgrade the existing Gateway Bridge River Crossing. The project included the duplication of the existing Gateway Bridge and the upgrade of 24km of the Gateway Motorway from Miles Platting Road to Nudgee Road. There were virtually three projects in one: the Gateway Bridge duplication; a 16km motorway upgrade (south) and a new 7km motorway deviation (north). However, many of the constructions sat on the flood plain area of the Brisbane River which underlain mostly by soft and saturated fluvial deposits. Low bearing capacity and excessive settlement were highly likely to occur and consequently jeopardize the stability and safety of the constructed facilities.

To minimize the risks caused by the soft soils, ground improvement was extremely necessary. The designer adopted prefabricated vertical drains (PVD) to accelerate the dissipation of excess pore water in soft deposit and therefore to cause an increase in shear strength and a decrease in compressibility. The contractor first placed a layer of ACETex[®] drainage blanket and a layer of gravelly platform on the surface of the ground. ACETex[®] provided functions of separation, filtration, and drainage so that the induced pore water could be easily dissipated without losing of fine particles. Then, PVDs were installed in square patterns (spaced 1.5m center to center) to cover all the treatment areas. As a result of this method of accelerating the consolidation process, bearing failure and excessive settlement can be virtually eliminated.

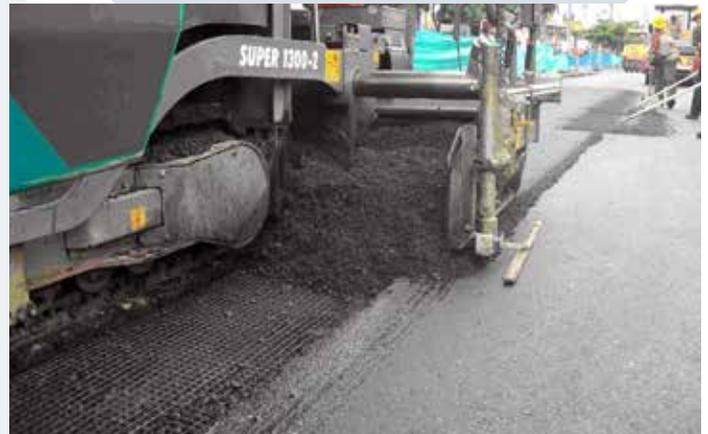
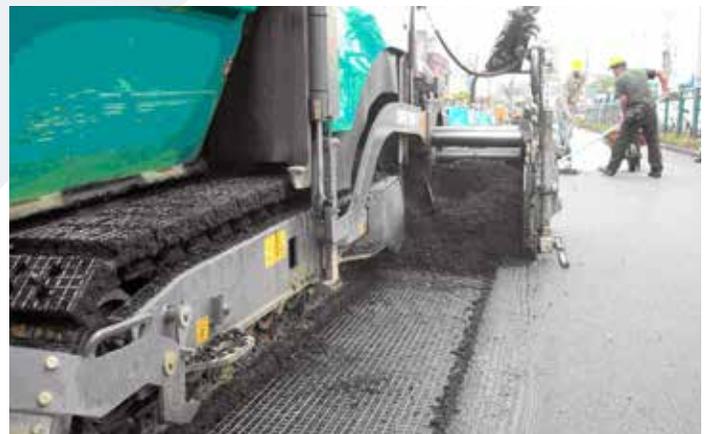
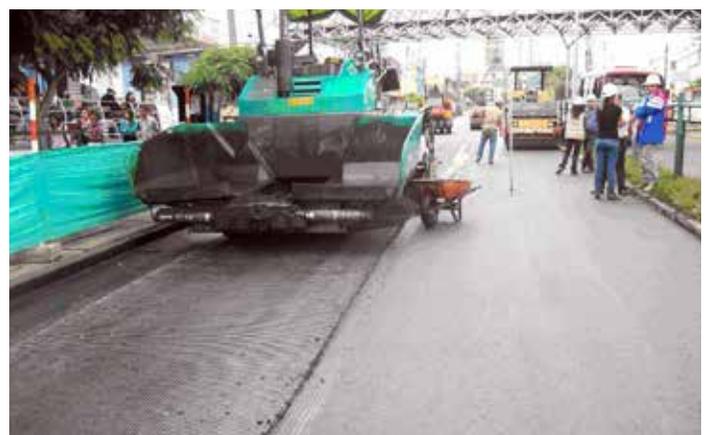
ACEGrid[®] GA is being increasingly used at asphalt overlay base level to enhance the overall performance. The asphalt reinforcement with ACEGrid[®] GA has advantage that it can be placed in the asphalt layer to restrict reflective cracks and ease of installation. In this project, after milling of the original pavement, it can be installed directly and overlaying with hot mix asphalt.

After the construction is completed, the performance of reinforced pavement showed very good condition. No reflective cracking and pothole are discovered. On the other hand, the depth of ruts is also decreased and has well serviceability.
