The Repair Project at Highway No. 27 in Kaohsiung

Location : Kaohsiung, Taiwan

Application : Reinforced Retaning Wall

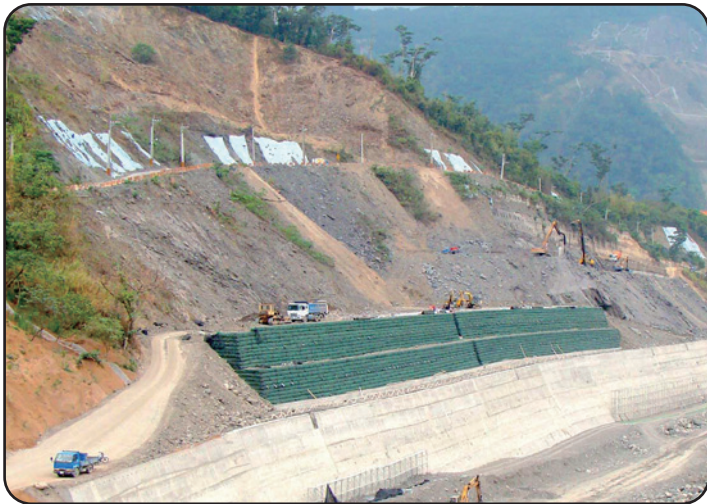
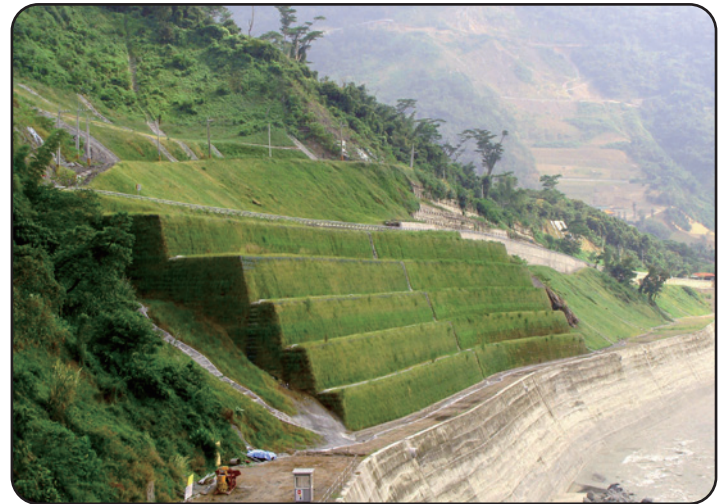
In 2009, Typhoon Morakot combined with southwesterly flow and invaded Taiwan; it affected southern Taiwan and brought high rainfall. This case was located at Highway No. 27, riparian area of Laonong River in Liouguei of Kaohsiung City in Taiwan. It was the main road from Liouguei to Laonong. However, the regional cumulative rainfall was over 2,600mm during the typhoon. The upper stream carried a large number of rocks and debris and constantly scoured the slope toe of the jobsite, resulting in road infrastructure loss and damage to overall structure which declined to cause interruption of traffic.

Due to this region was in the attack side, the concave bank of the river, a semi-gravity retaining wall was built below the normal water level, and above it, a reinforced retaining wall was built by using ACEGrid[®] and other geosynthetic materials including ACEBag[®], ACETex[®] and drainage system. Besides, in-situ soil was used as the backfill of the reinforced structure. The design significantly reduced using more than 2/3 amount of concrete at least, which definitely meets the main goal of energy saving and carbon emission reduction. Thanks to the suitable design, this project was presented better than expected after Typhoon Nanmadol hit in 2011.
